USAAMRDL TECHNICAL REPORT 71-34

**THREE-AXIS FLUIDIC STABILITY AUGMENTATION
SYSTEM FLIGHT TEST REPORT**

EUSTIS DIRECTORATE
U. S. ARMY AIR MOBILITY RESEARCH AND DEVELOPMENT LABORATORY
FORT EUSTIS, VIRGINIA

CONTRACT DAAJ02-70-C-0017
HONEYWELL, INC.
MINNEAPOLIS, MINNESOTA

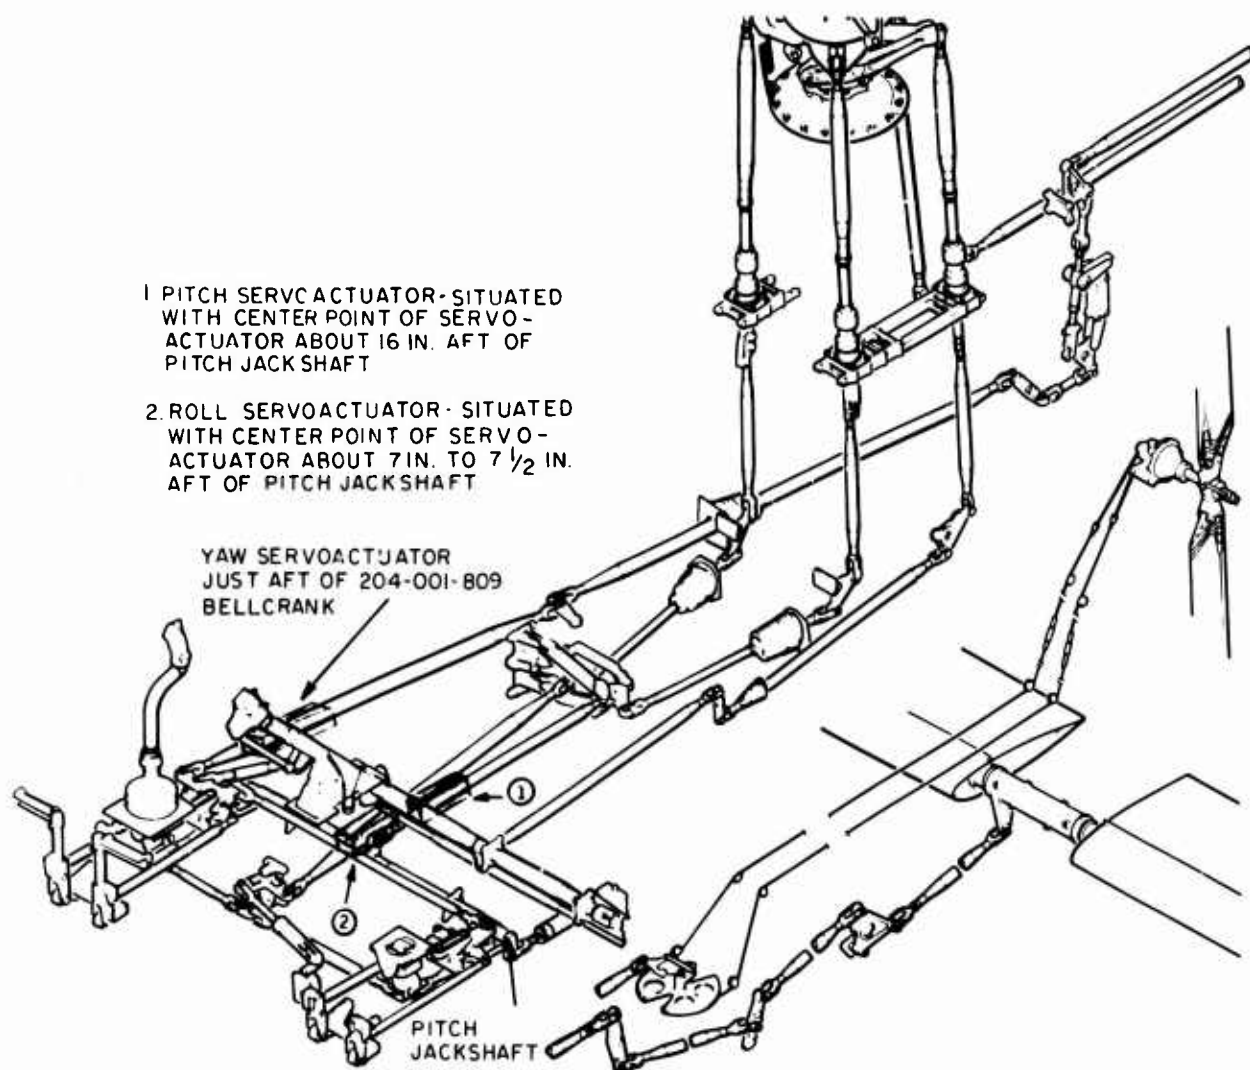
Figure 1. Servoactuator Installation Schematic.

Figure 1 is a schematic of the servoactuator installation, showing the approximate location of the three servoactuators. During installation it became necessary to cut a larger hole in the bulkhead at station 66 so that roll and pitch servoactuators could be installed. Figure 2 shows the hole in this bulkhead with the stiffeners and doubler that were added. To provide enough clearance for the roll-axis servoactuator, it was necessary to remove the throttle linkage that connects the copilot's throttle to the pilot's throttle linkage. This is discussed further in Appendix III. To install the yaw-axis servoactuator, the control rod hole in the bulkhead at station 52 was enlarged and a stiffener and doubler were added, which is shown in Figure 3. The pitch jackshaft that connects the pilot and copilot controls was modified. The original installation used a swivel-type bearing in the arm assembly. The arm assembly was replaced with a newly fabricated part using a fixed bearing. This prevents the servoactuator, which connects through a control tube that attaches to the arm assembly, from rotating and possibly hitting the roll servoactuator or bulkhead.

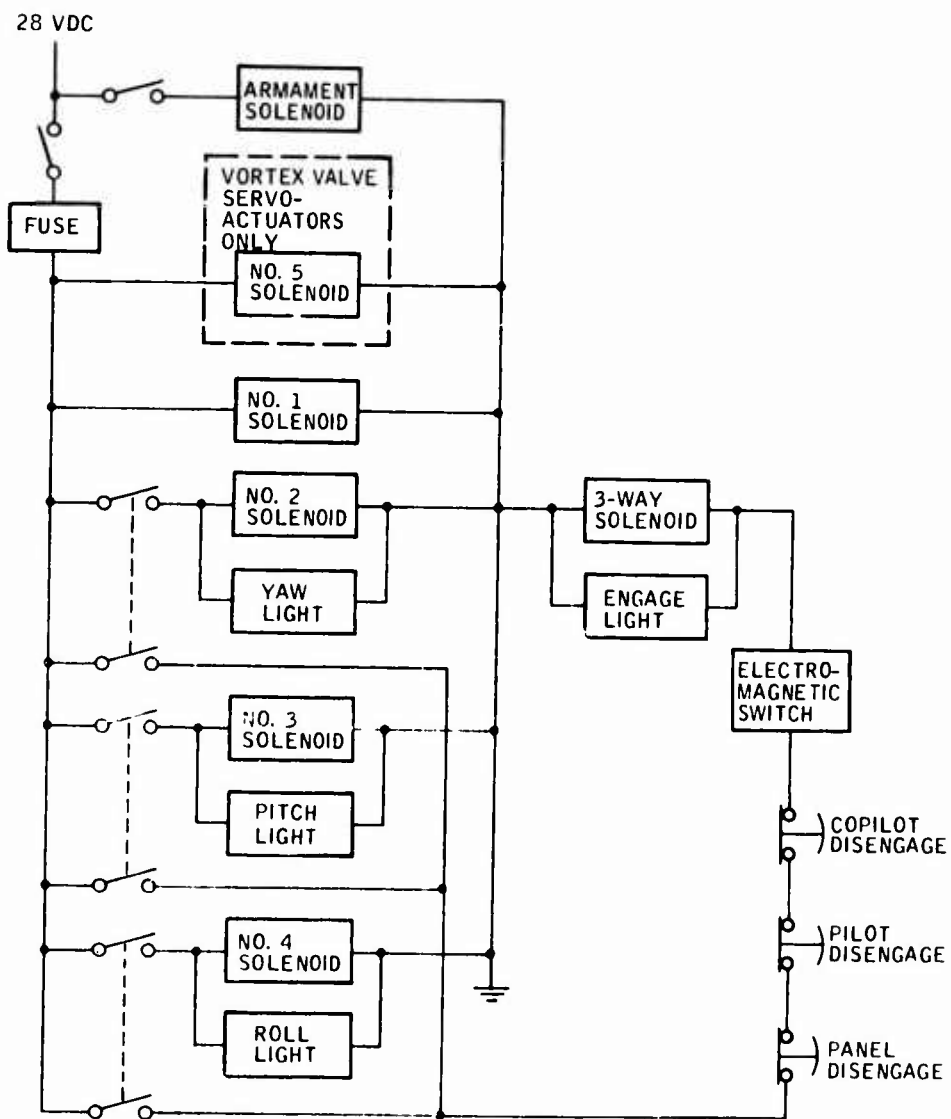
Figure 30. FSAS Operation Electrical Circuit Diagram.

Solenoid valves were used in the power circuit to provide the capability of shutting off portions of the system, or the complete system, in case of a catastrophic failure such as a line rupturing. The electrical schematic of this engage and disengage provision is shown in Figure 30. (Refer also to Figures 16 and 19.) With this circuit it was possible to engage or disengage any servoactuator independently of the others, to actuate the disengage provisions of the servoactuators from the pilot seat, copilot seat, or control panel locations, and to shut off the complete system. An additional solenoid was added when the vortex valve servoactuators were installed so that the power supply could be shut off at the discharge of the No. 2 aircraft hydraulic power supply. Figure 31 shows the layout of the switches located on the pilot console.

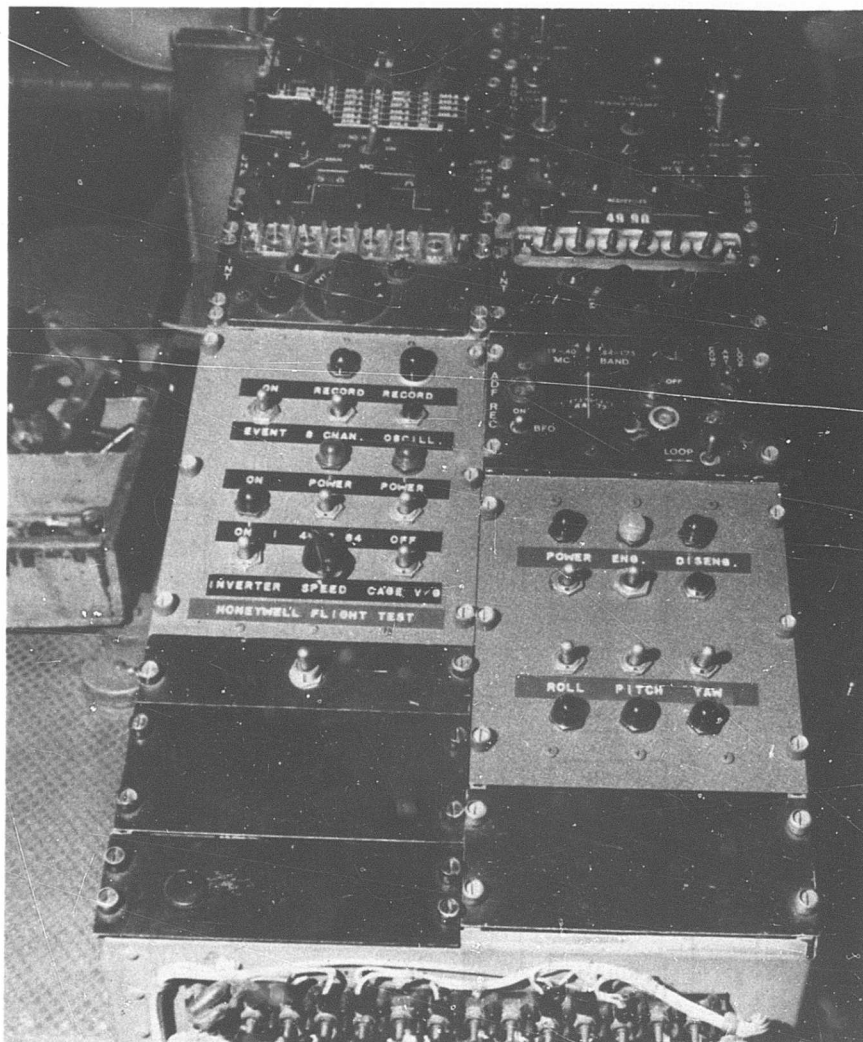
Figure 31. Pilot's Console.

The control of the electrical supply for the instrumentation equipment, the recorder on-off switches, the 8-channel recorder speed control, and the vertical gyro cage-uncaging switch were all located on the pilot console shown in Figure 31.

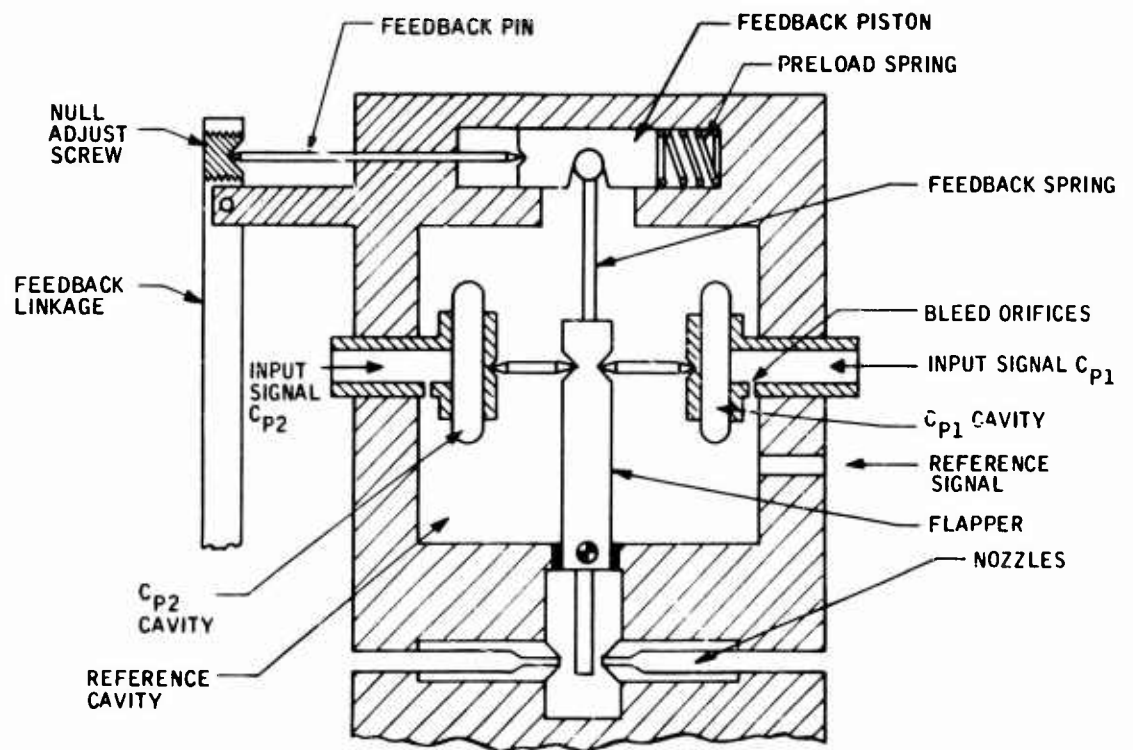
Figure 32. Schematic of Spool Valve Servoactuator --
Input Portion.

NOTE: INPUT SIGNAL AND REFERENCE
SIGNAL PORTS CONNECT TO THE
CONTROLLER

Initial test flights were made with the stabilizer bar on to obtain basic aircraft data for this configuration. Some preliminary checks of the FSAS were also made. It was noted that during preflight checkout of the aircraft, electrical power was interrupted twice. Because of the solenoid valves in the circuit, rather large pressure surges were being imposed on the servoactuator force capsules. (It had been assumed that pressure on the FSAS would be increased gradually by being connected to the hydraulic pump while the engine was started and run up.) These pressure surges on the servoactuators caused the yaw and roll servoactuators to fail. The failures were traced to the feedback pin (see Figure 32). During the pressure surge, the servoactuator would move in such a way that the feedback pin would move out of the null adjust screw seat. Most of the time it would slide back into position, up the sloped wall of the seat, and function satisfactorily. Examination of the pin and seat showed that the pin had gouged the seat quite badly and failed to reseal. The seat and pin were cleaned with grinding compound after which the servoactuators functioned properly. To eliminate the reoccurrence of the pressure surges during startup of the aircraft and preflight checkout, a manual-operated valve was added to the FSAS supply line just downstream of the flow control valve shown in Figure 17. This valve was opened only after the aircraft was ready for flight.

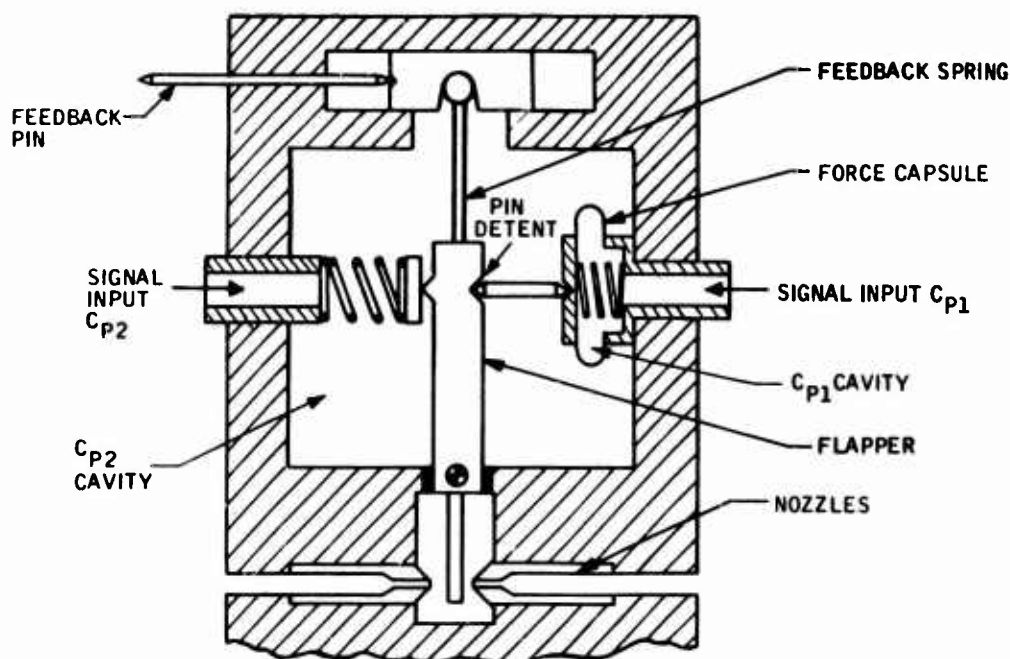
Figure 43. Schematic of Vortex Valve Servoactuator -- Input Portion.

The vortex valve servoactuators are slightly different in their input configuration than the spool valve servoactuators. As shown in Figure 43, the cavities for the signal inputs for the vortex valve servoactuators are dead ended, while the spool valve servoactuator (Figure 32) has a bleed orifice between the input signal line and reference signal line. There is no steady-state flow through the lines from the controller to the vortex valve servoactuator, as in the spool valve servoactuator, due to the lack of bleed orifices. Also, the cavity designated C_{p2} is quite large compared with cavity C_{p1} . These differences make it extremely difficult in the aircraft installation to prevent the accumulation of air, or removal of trapped air from the lines and cavities. Therefore, assuming trapped air in cavity C_{p2} of the vortex valve servoactuator, prior to startup, a finite time will be needed to compress this air to the operating pressure (350 psi in the yaw-axis servoactuator), while cavity C_{p1} , which has no

trapped air, will charge up almost immediately upon pressurization. The differential pressure that develops across the force capsule can destroy it.

The yaw-axis servoactuator was damaged during startup of the aircraft when part of the aircraft preflight was done after the manually operated valve had been opened (see Figure 19 for circuit details). The aircraft has two hydraulic systems, and it is possible to use each one independently to supply the boost servoactuator power. In so doing, the No. 2 system is shut off with a solenoid valve while the No. 1 system is being checked, and vice versa. This checkout procedure resulted in a pressure surge being applied to the servoactuator input force capsule, thus rupturing it.

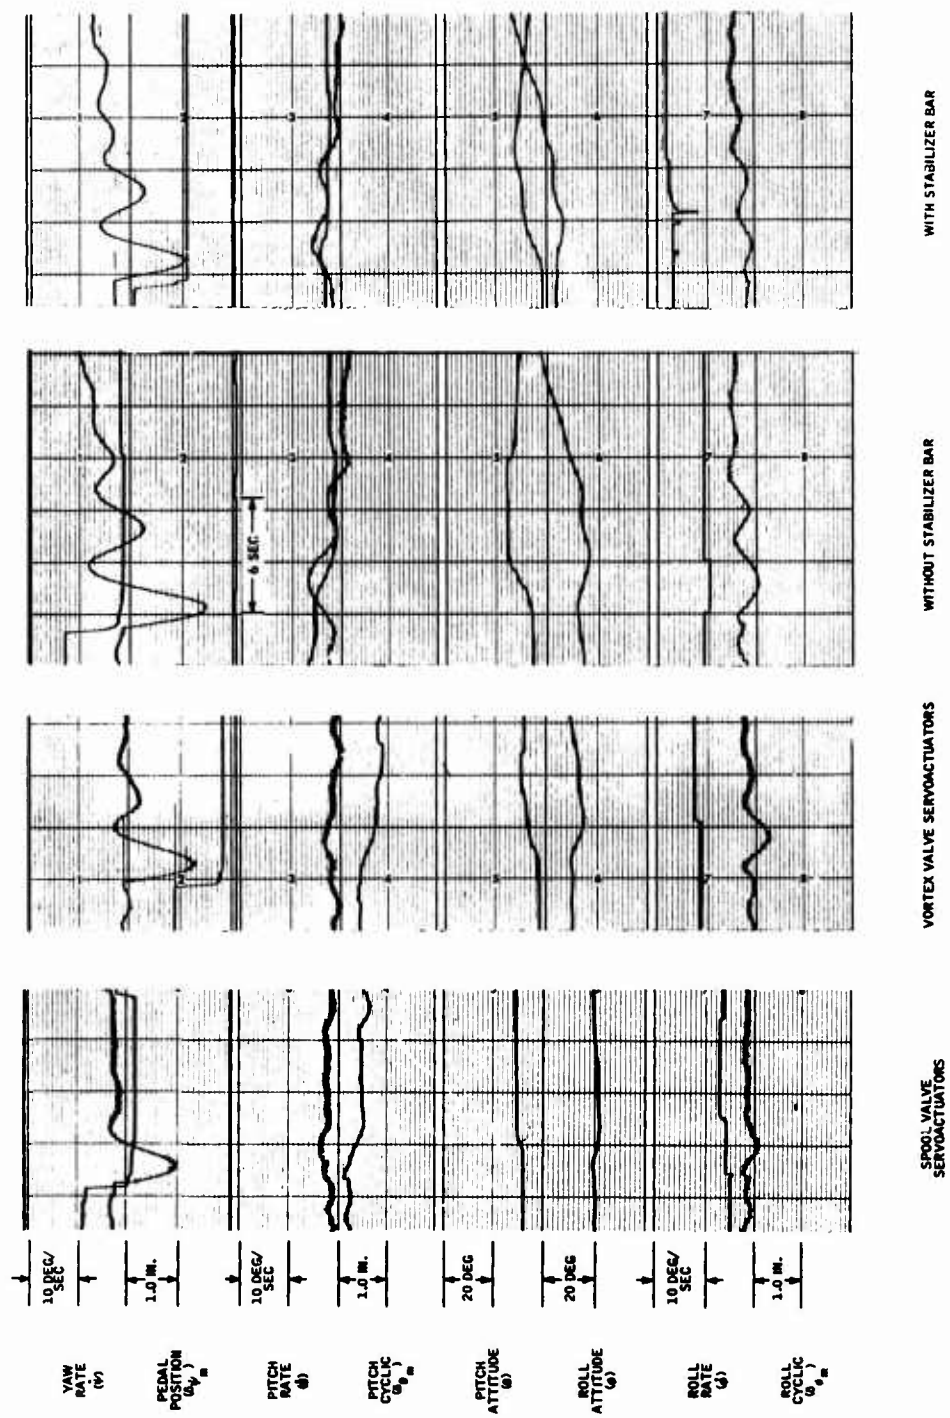
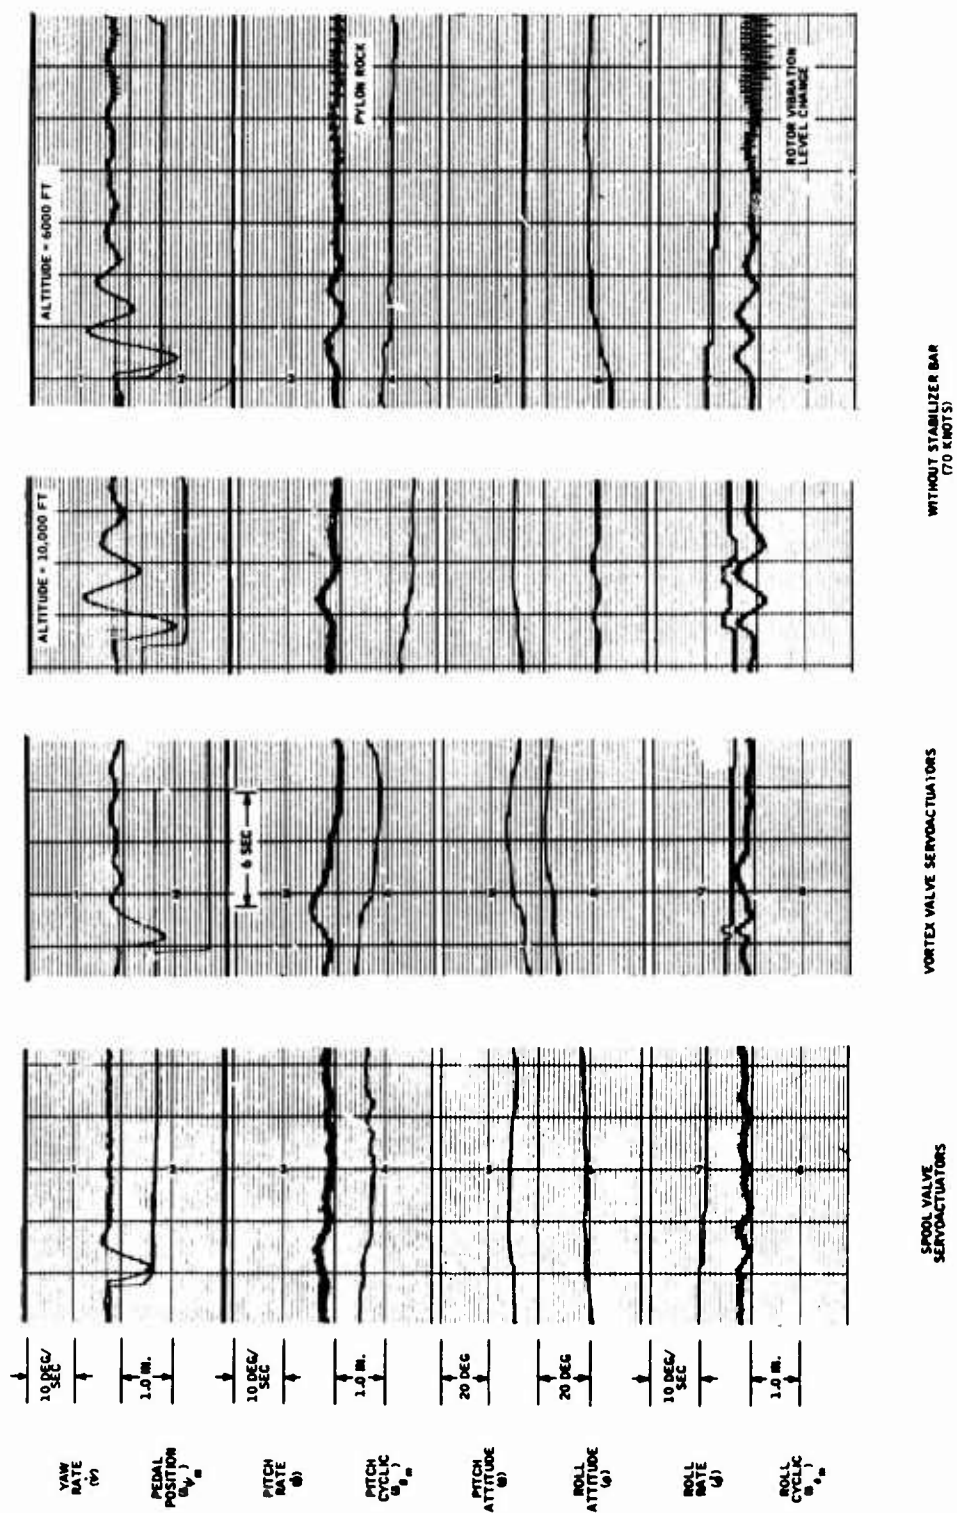
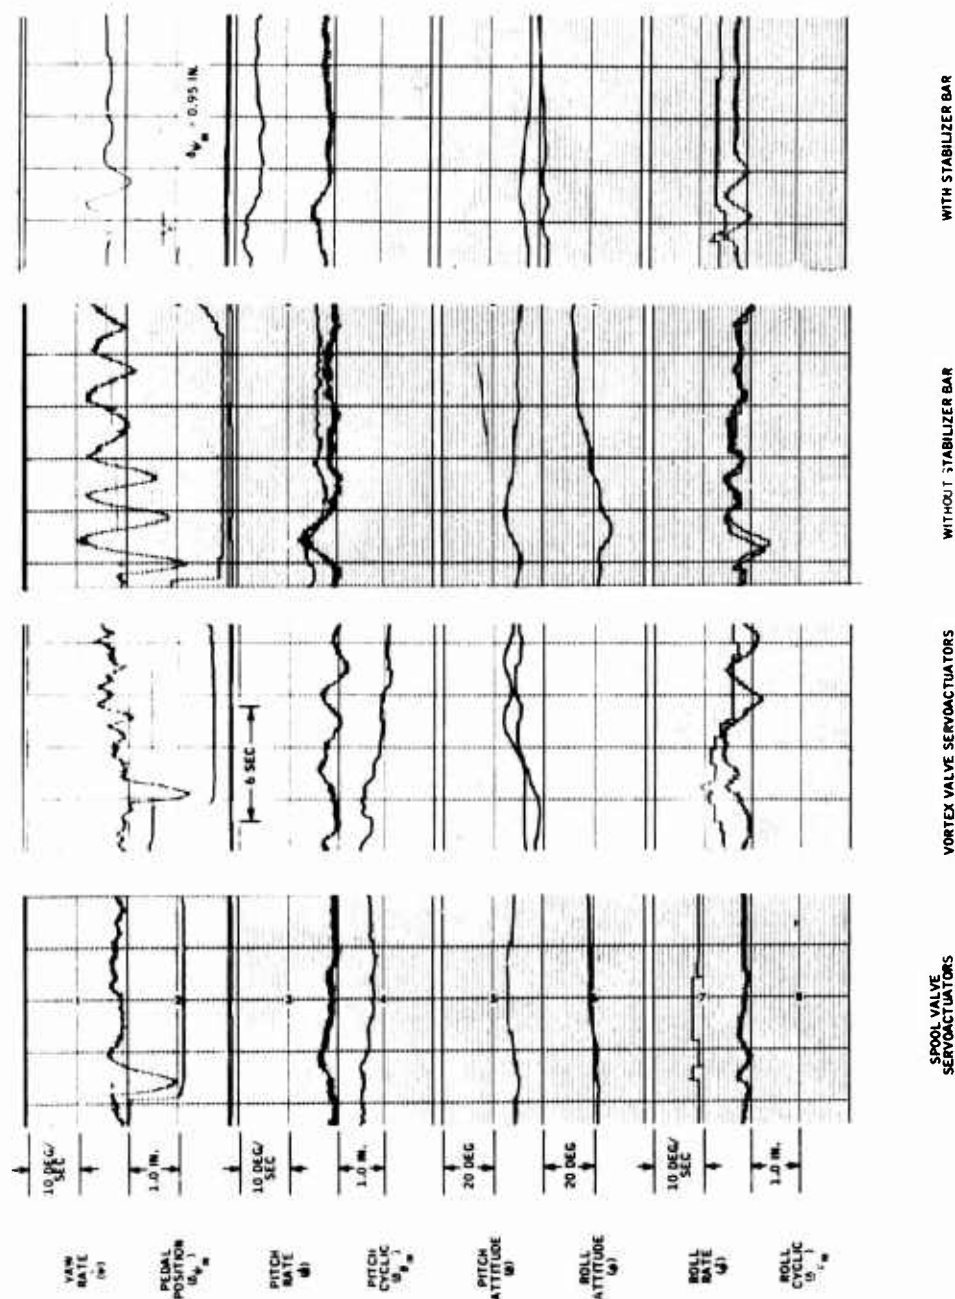
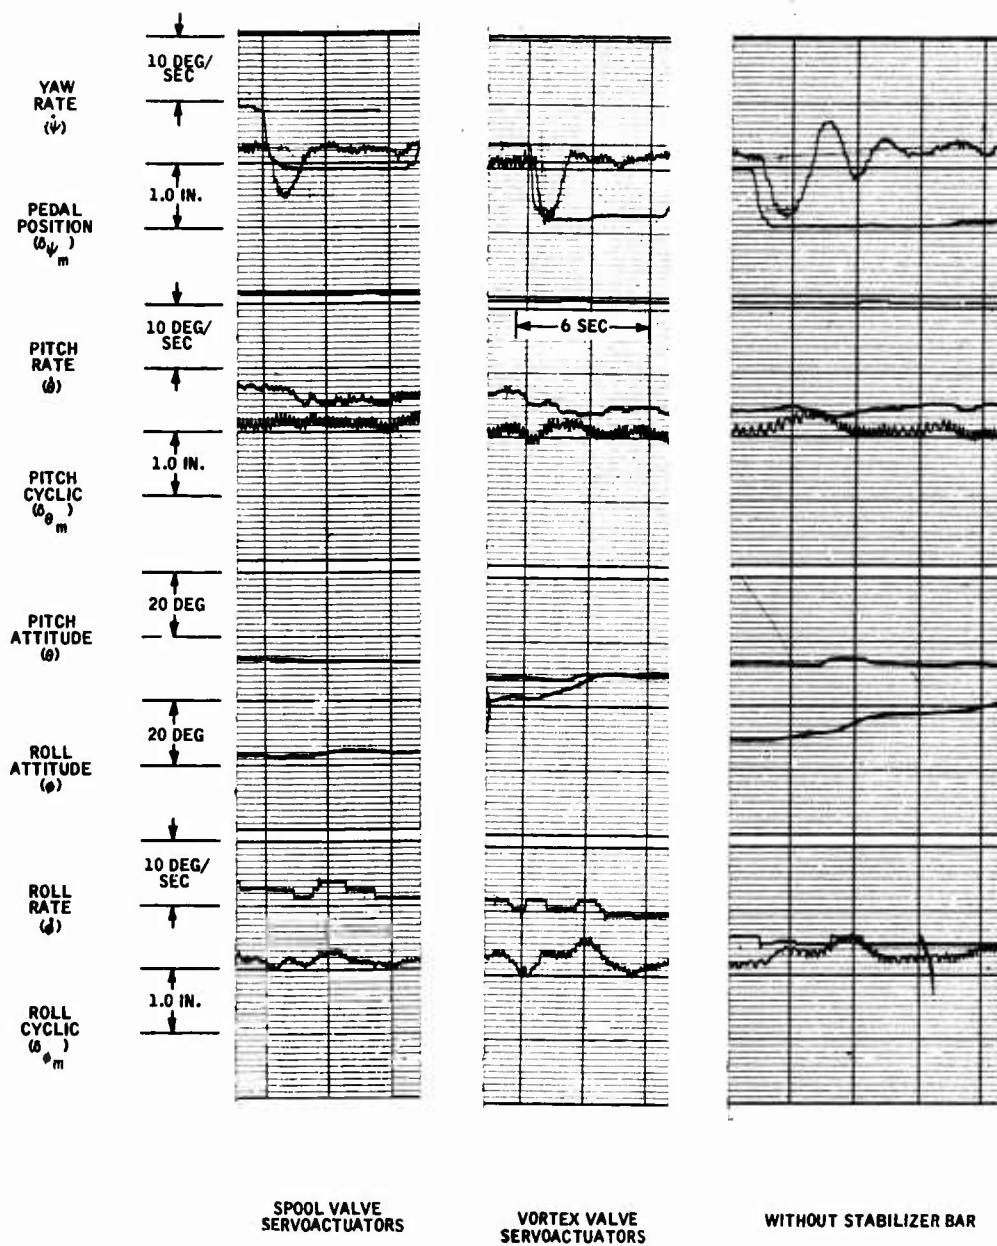
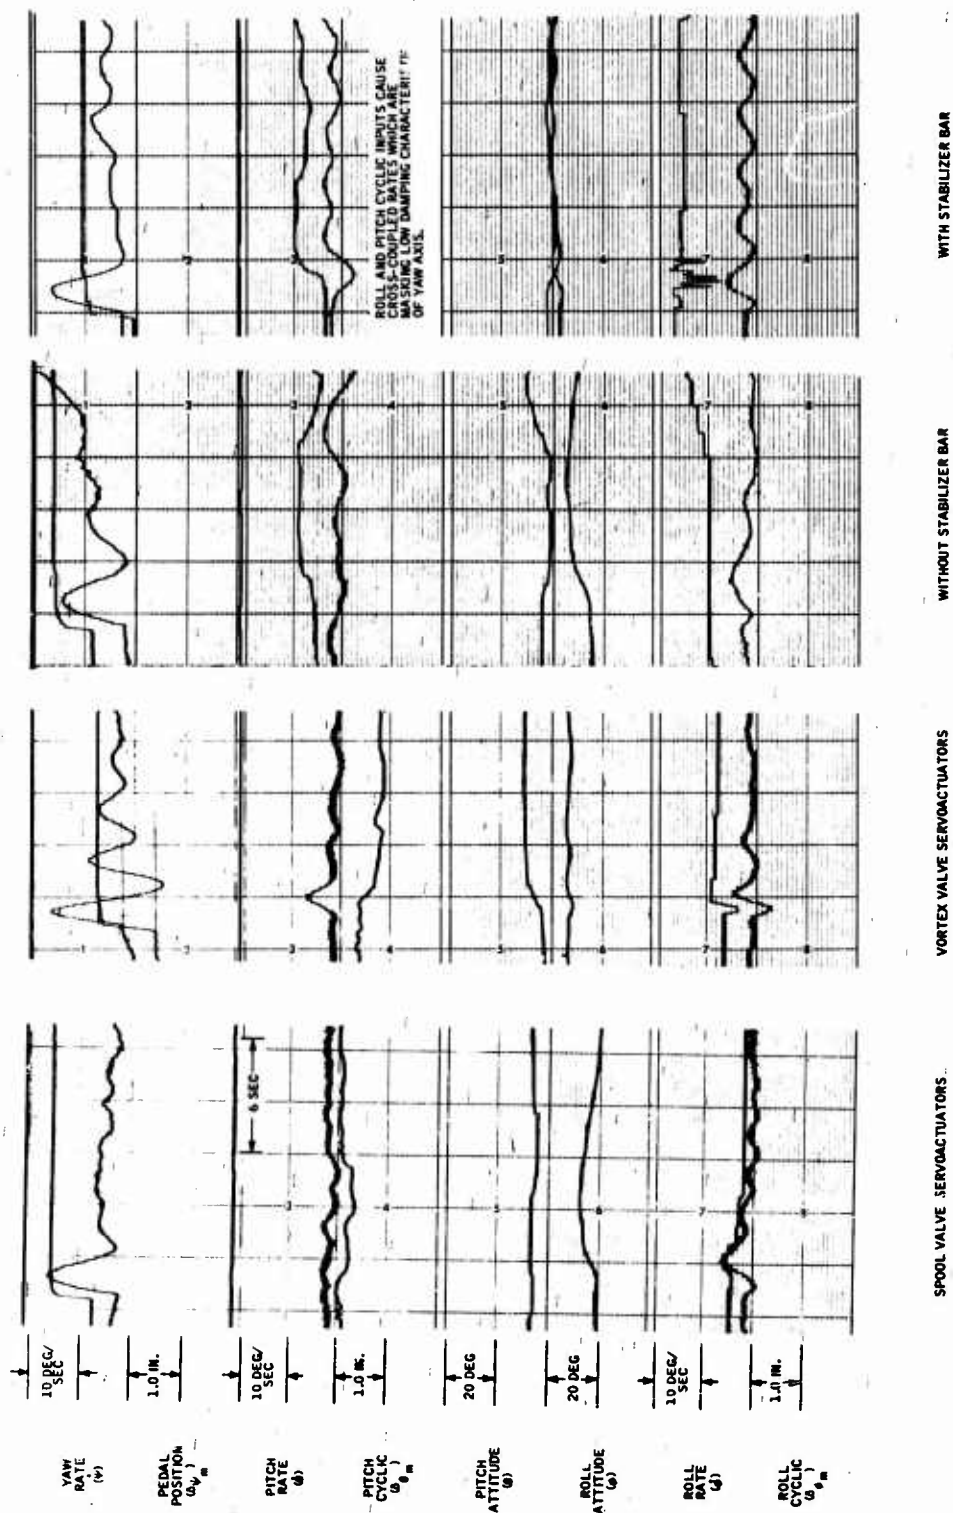
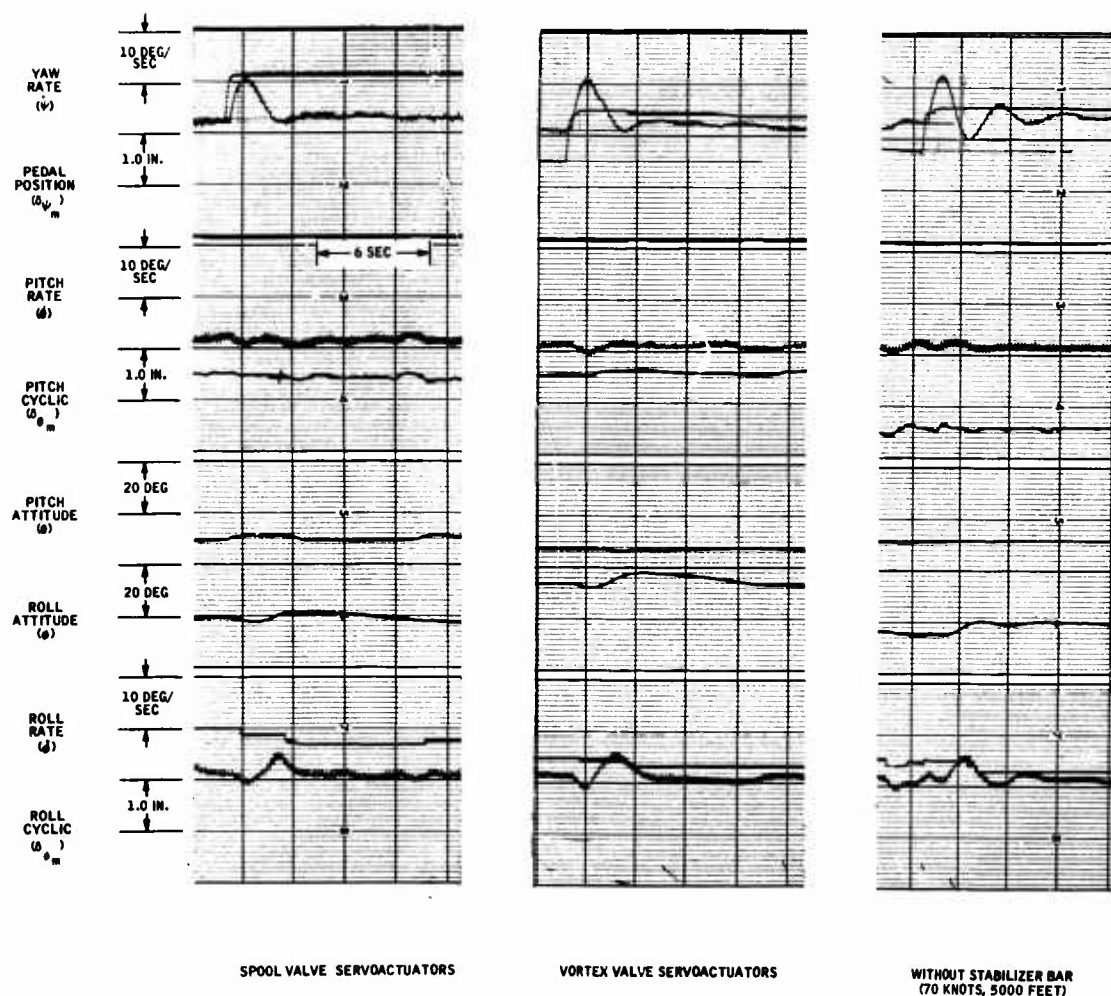
Flight recordings for the vortex valve servoactuators plus FSAS combination pedal step input tests are also presented in Appendix II. Figures 44 through 53 show that yaw rate response for these tests was underdamped and jerky. These undesirable response characteristics were caused by servoactuator threshold nonlinearities. That is, the servoactuator did not linearly follow FSAS commands, but moved in discrete steps. As the flight test program progressed, this servoactuator problem became worse, and FSAS performance, with vortex valve servoactuators, deteriorated significantly. This problem area is covered in greater detail in Section IV.

- Yaw step - right (Figures 44 through 48)
- Yaw step - left (Figures 49 through 53)
- Yaw pulse - right (Figures 54 through 58)
- Yaw pulse - left (Figures 59 through 63)
- Roll step - right (Figures 64 through 68)
- Roll step - left (Figures 69 through 73)
- Pitch step - down (Figures 74 through 78)
- Pitch step - up (Figures 79 through 83)
- Pitch pulse - down (Figures 84 through 88)
- Pitch pulse - up (Figures 89 through 93)
- Autorotation (Figure 94)

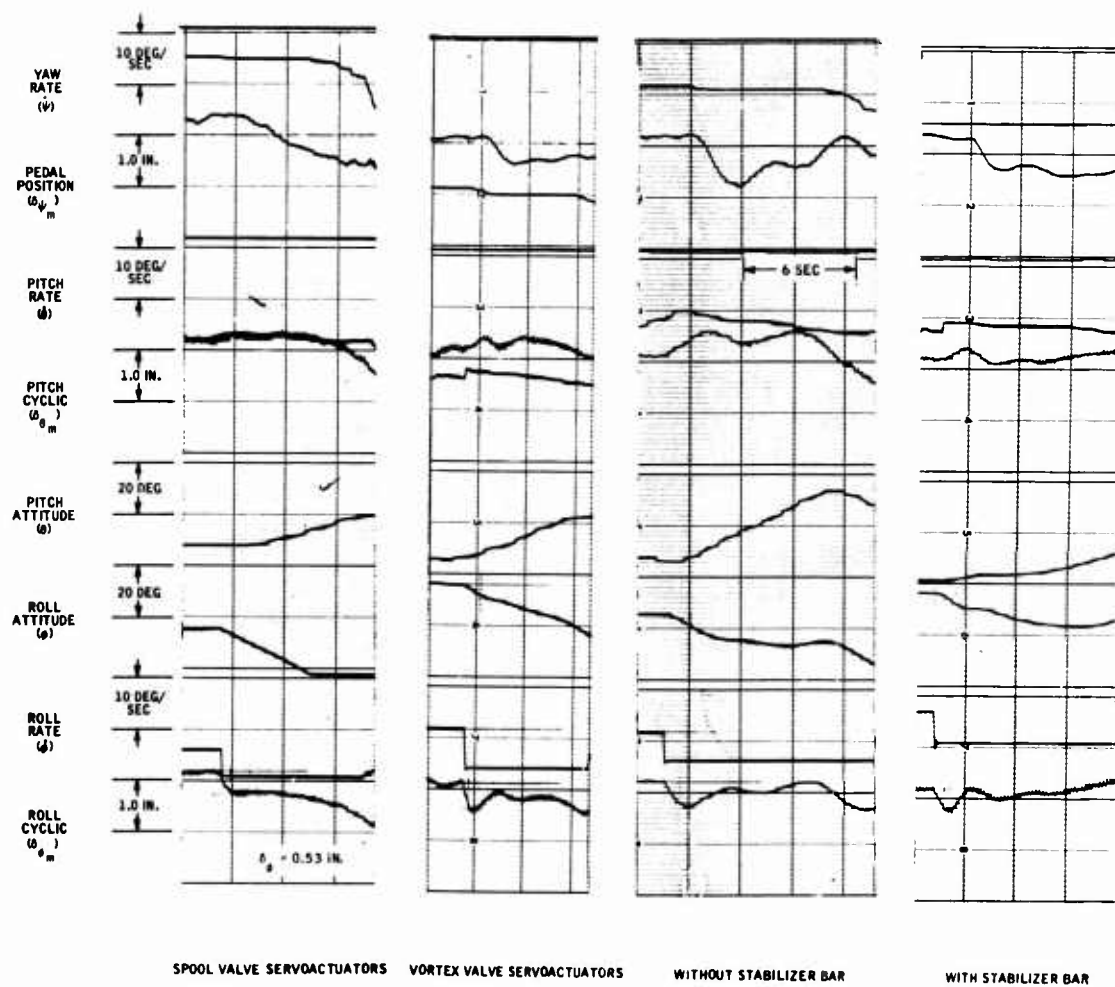
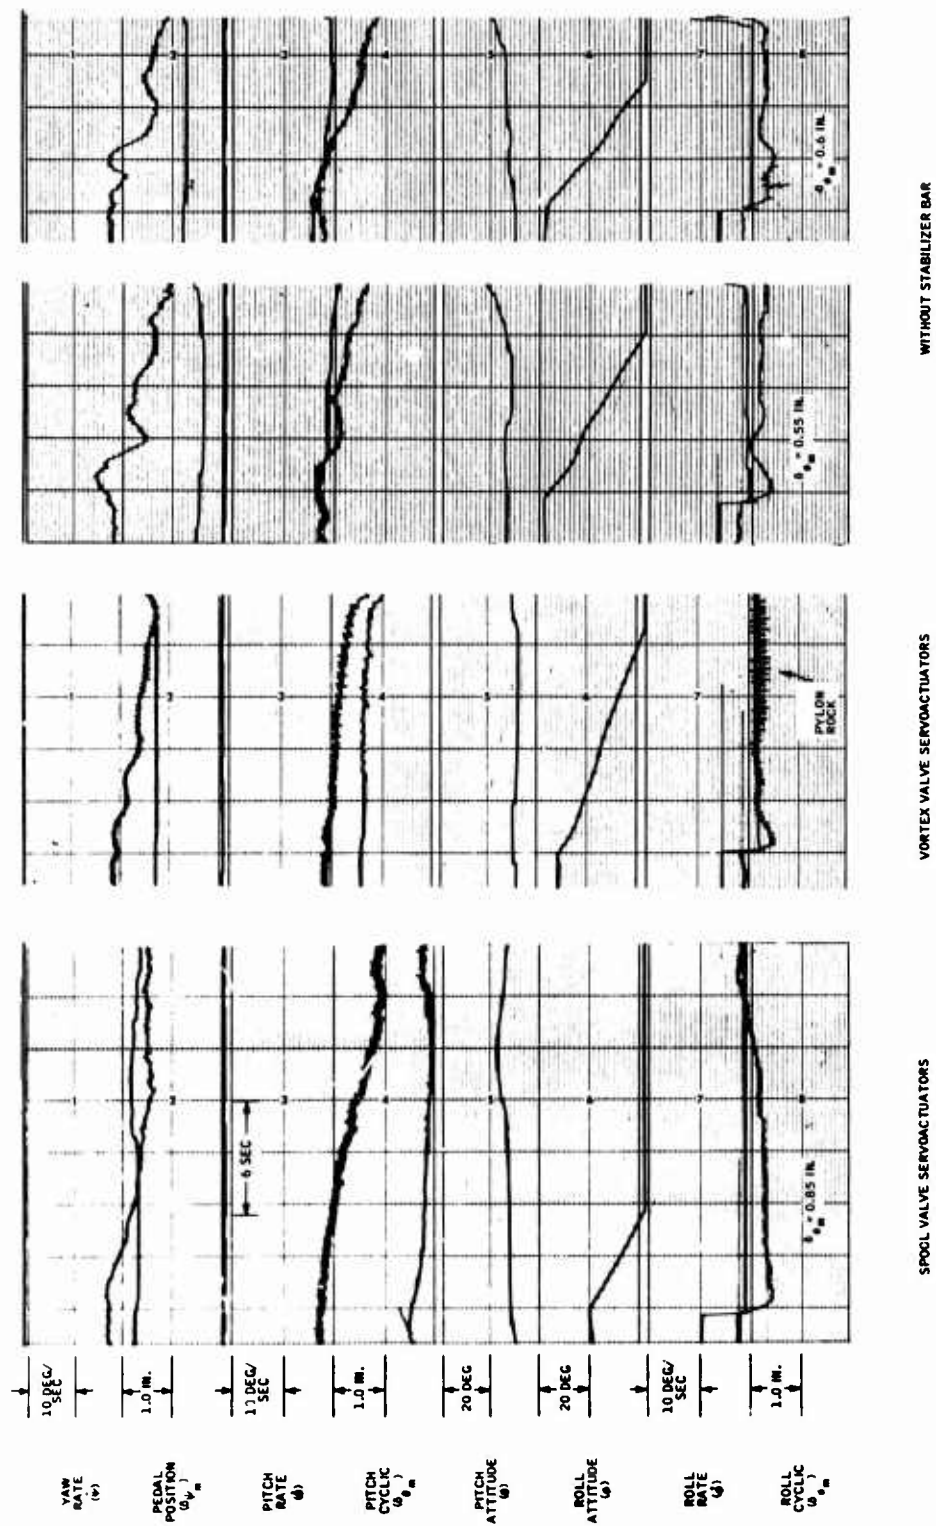
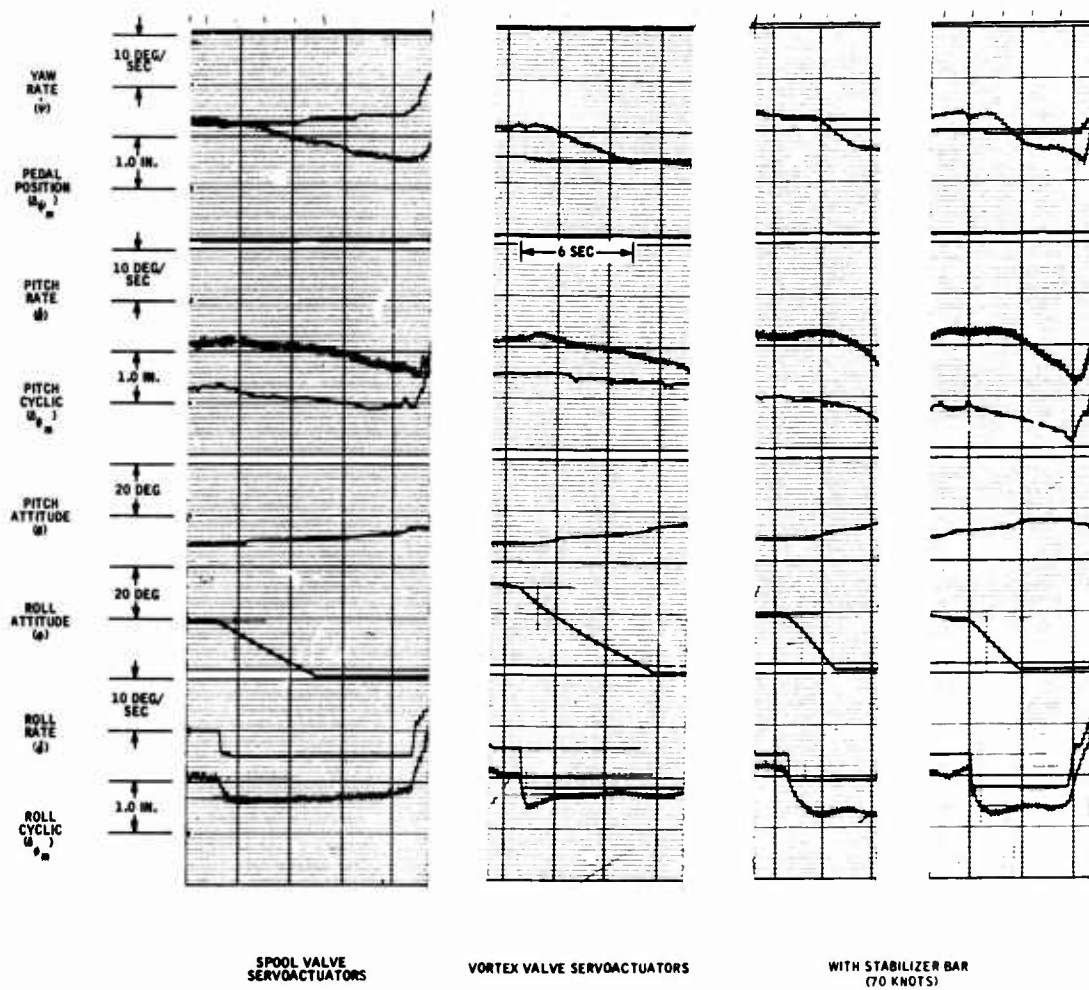
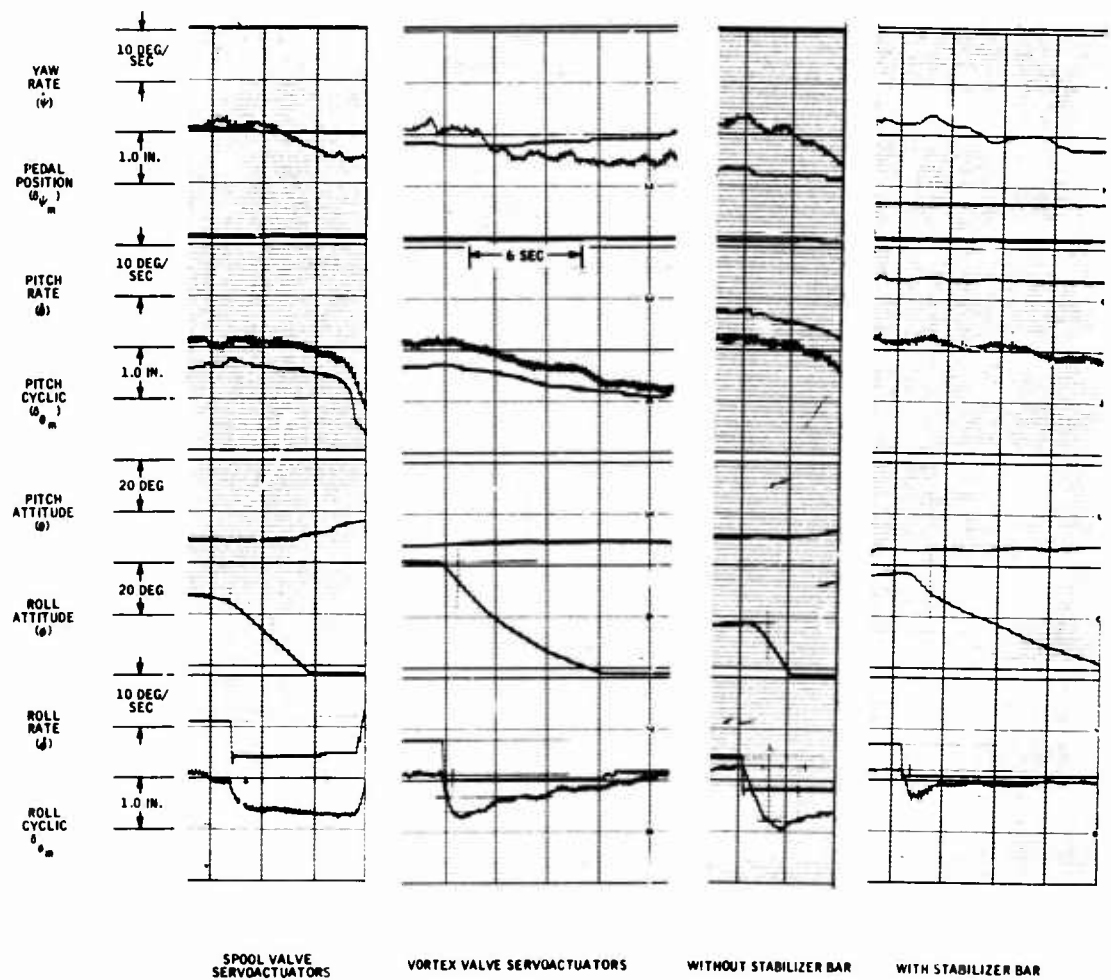
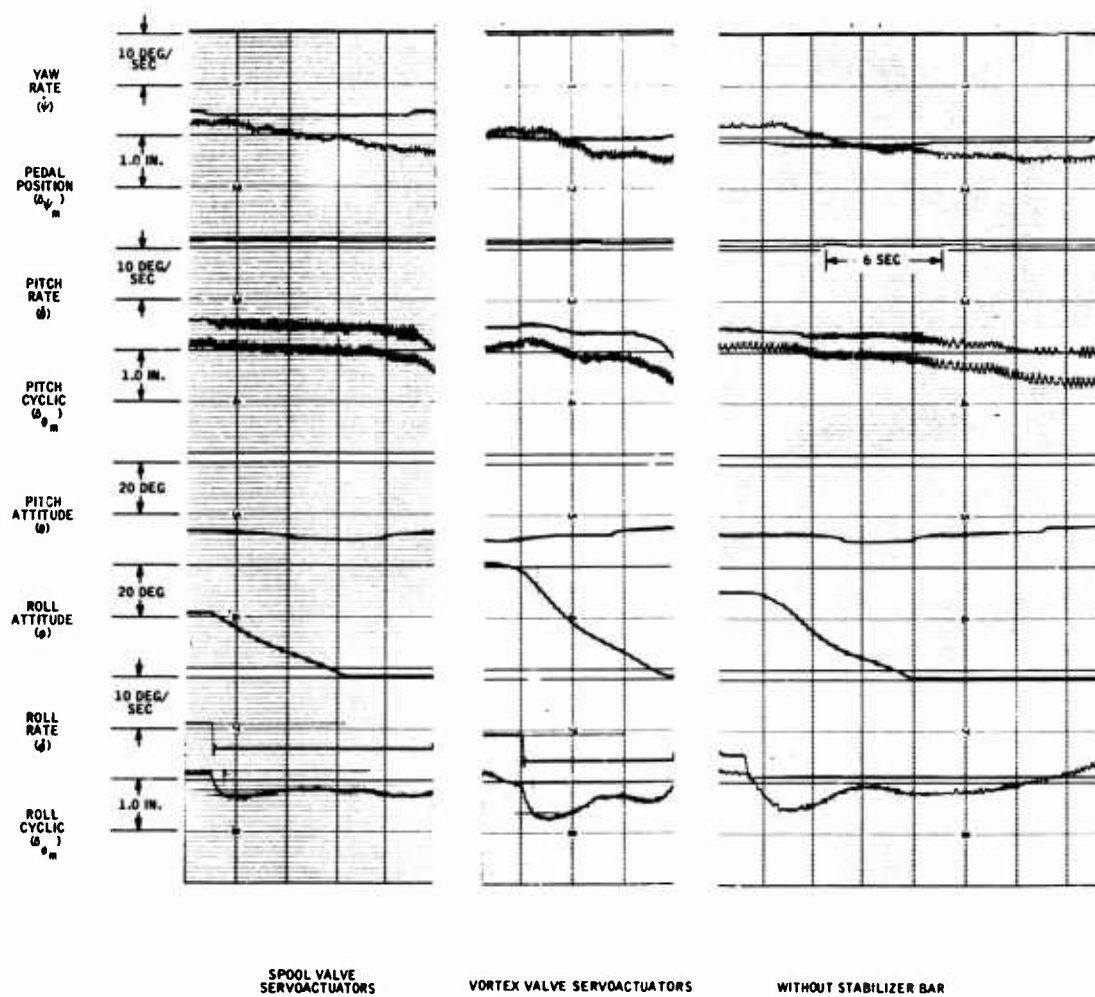
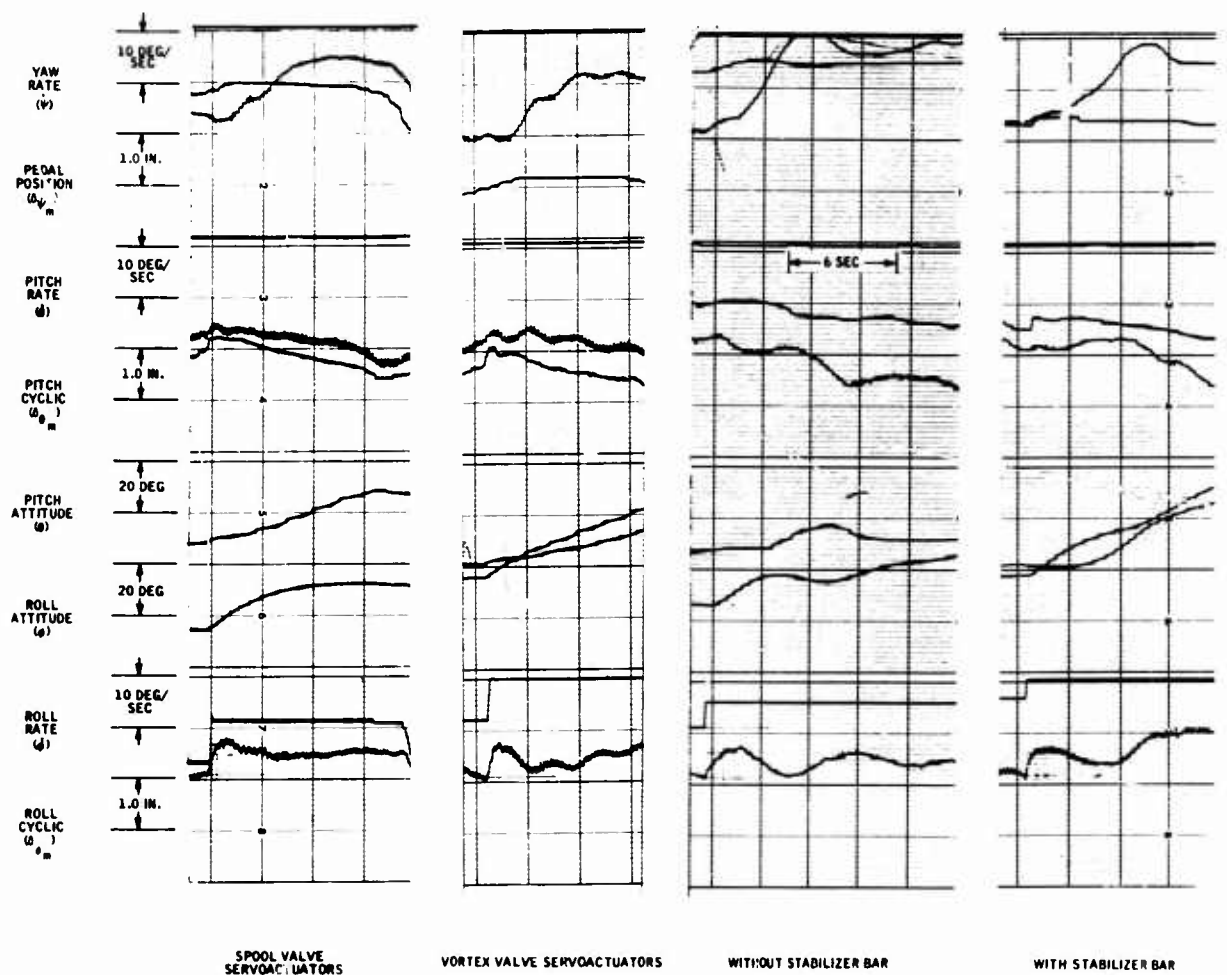
Flight recordings showing helicopter roll-axis response characteristics for the FSAS with vortex valve servoactuator are also shown in Figures 64 through 73. Roll rate responses for this system are characterized by large rate overshoots and, at some flight conditions, such as hover and 90 kn, a wandering roll rate response. The gross shape of the rate responses is similar to that of the unaugmented helicopter. These response characteristics are caused by the high thresholds in the vortex valve servoactuator. The control sensitivity data of Table V does show, however, that this system reduces control sensitivities of the UH-1C without mechanical stabilizer bar to comparable levels obtained with spool valve servoactuators.
